**YAMAHA****MEASURE REPORT**

REF. No. MC-88049

MODEL	TDR240/250, TZR250	FILE	
SUBJECT	PISTON MELTING AT CROWN

MODEL	TZR250 '87, '88	FILE	
SUBJECT	PISTON SEIZURE

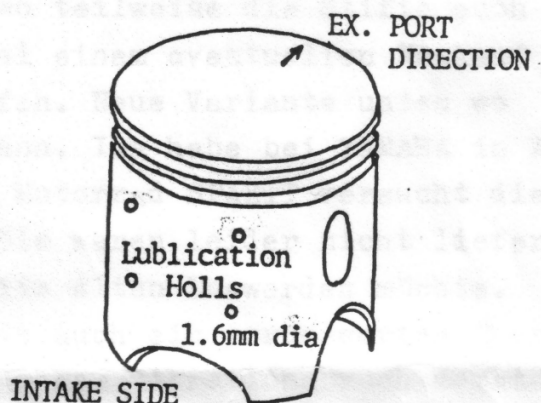
At the early break-in of an units, some units may be experienced scaffing between piston and cylinder wall insurficiant lublication. Then scaffing caused to piston seizure.

To prevent scaffing at early break-in, we are going to change the piston design as similure with 2YK type (TDR250) as a next model. The 2YK type piston has four location of lublication holls at intake side as shoun in the left. These holls will provide greater lublication effect between piston and cylinder wall comparison with present ones.

If you encounter a smilure problem, please recommend your dealer to use following part instead of STD ones. Recommended piston is as same as TDR250 model's one.

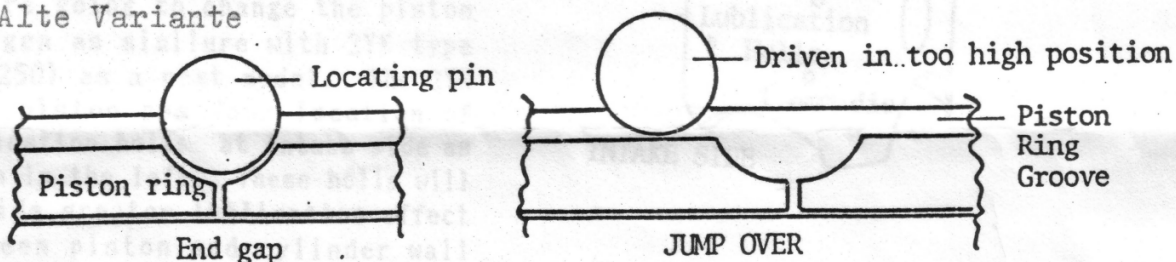
Alte Variante

Market report indicates that the a piston ring is broken catching with cylinder port.

The piston ring located pin may be experienced driving into piston ring groove with insufficient dimension accuracy in some units (drivig upward comparison with specified location) . And also locating pin can be worn. These matter may cause that piston ring end gap can jump over the locating pin and then end gap will catch with cylinder ports. See below.

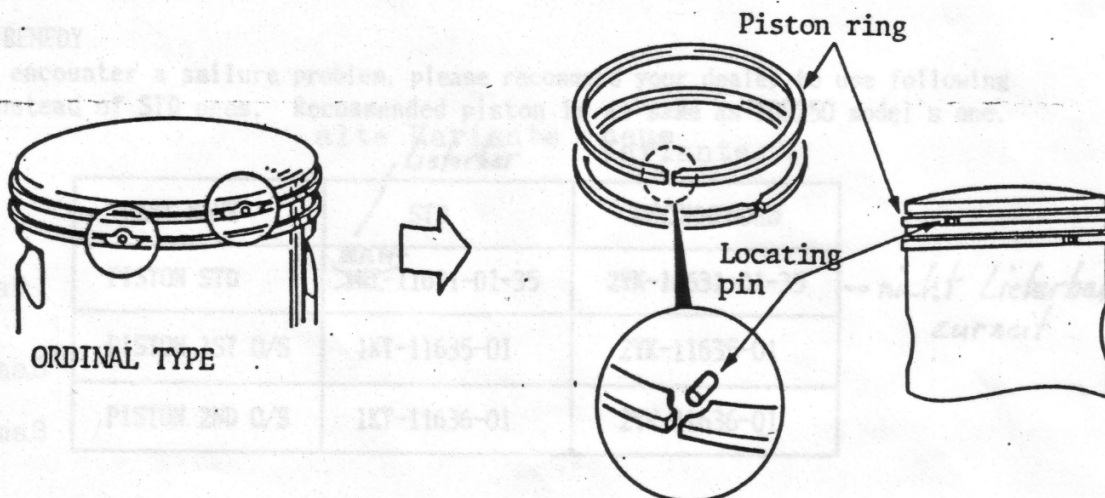
neue Variante

YZ TYPE LOCATING PIN

To prevent jumping over, locating method of piston ring will be changed to YZ type as shown in below. Now we are investigating this remedy to employ with next model.
